Professional Installers Trouble Shooting Guide

MICROINVERTERS COMMUNICATION AND PRODUCTION ISSUES

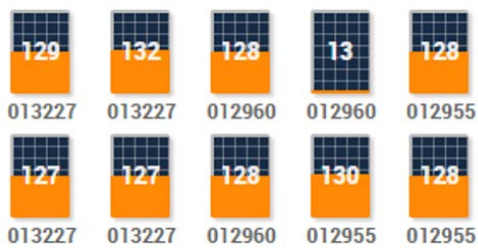
1 channel only:

On the Module View in the EMA, typical behavior of a low power or no power generation displays 0W or 2W, or much lower power than other modules while there is no known shading patterns.

Typical “Module View” of microinverter(s) being impacted by low or no power:

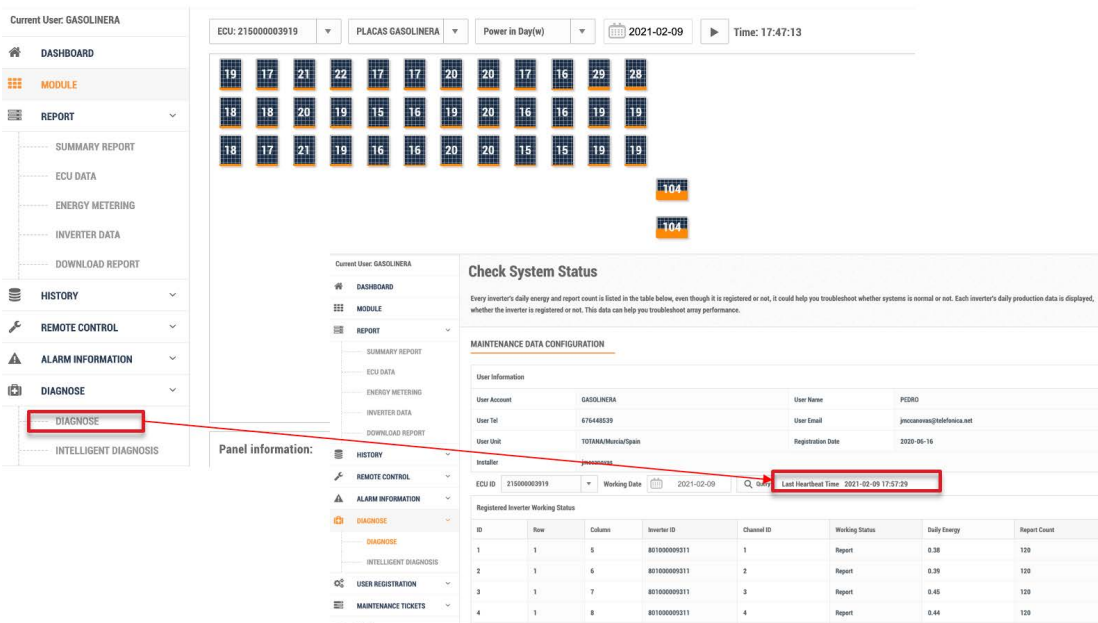
In the menu “Diagnose” > “Diagnose”, please check “Last Heartbeat Time” information

The screenshot shows the APsystems web interface. On the left, the 'DIAGNOSE' menu item is highlighted with a red box. A red arrow points from this box to the 'Last Heartbeat Time' field in the 'Check System Status' page, which is also highlighted with a red box. The 'Last Heartbeat Time' is shown as '2021-02-09 17:57:29'.

Before going through the trouble-shooting tree in the next chapter, we need to define the “ECU Heartbeat” The ECU Heartbeat feature registers the time of the latest communication and data exchange between the ECU and the EMA server.

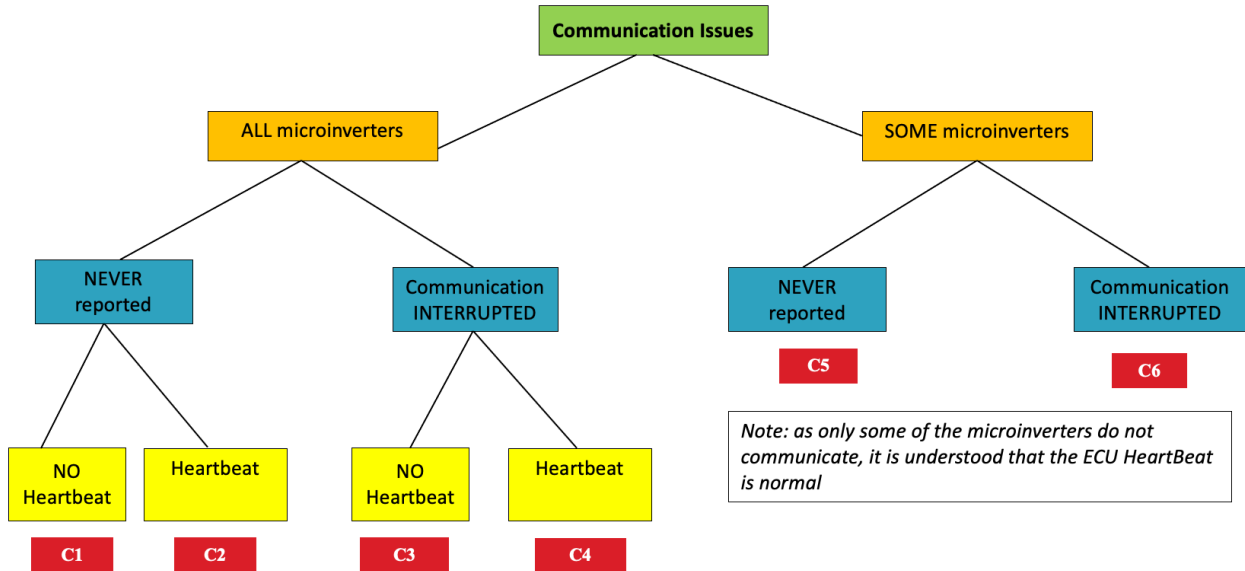
5. Communication Issues – Trouble Shooting Tree

The diagram above summarizes the typical situations (C1 to C6) installer can face when troubleshooting microinverters communication issues.

Each branch of the tree is detailed in the next pages, with some recommendations and troubleshooting tips for each of the situation.

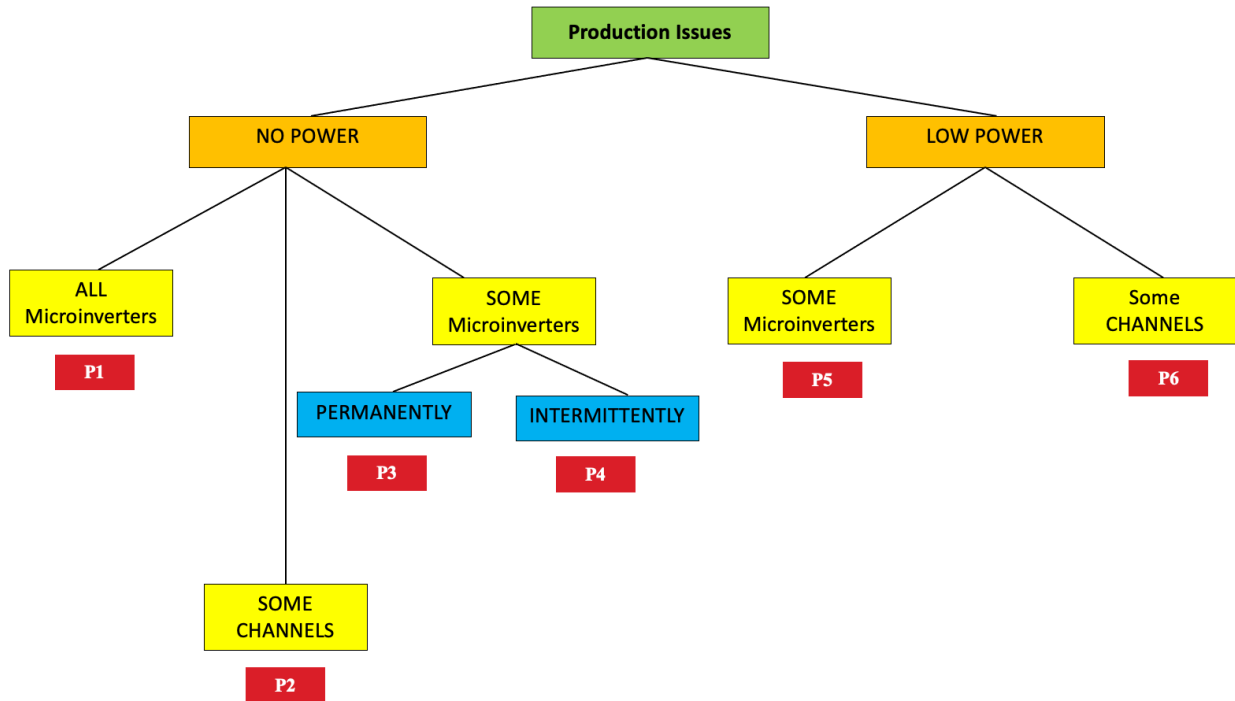
6. Production Issue – Trouble Shooting Tree

The diagram above summarizes the typical situations (P1 to P6) installer can face when troubleshooting microinverters production issues.

Each branch of the tree is detailed in the next pages, with some recommendations and troubleshooting tips for each of the situation.

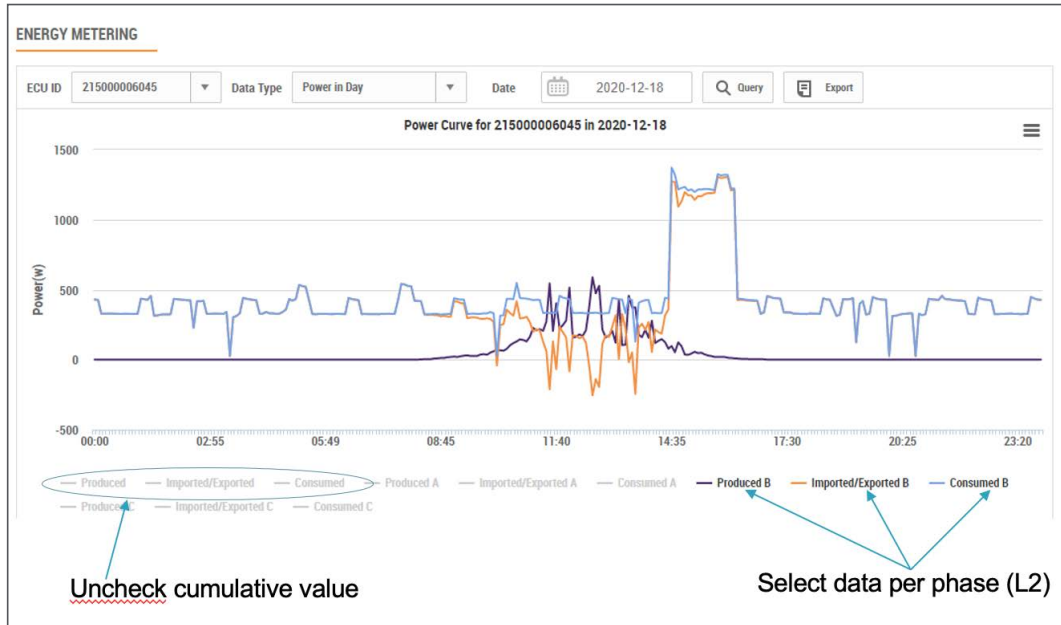
When doing the sanity checks described further below on a 3-phases systems, the analysis must be done phase by phase.

Sanity check on Energy Metering curves:

- PV production is measured (green curve) and is always showing positive data
- Grid consumption or re-injection is measured (grey curve) and can be either positive (when we pull power from the grid) or negative (when we re-inject power into the grid)
- The Load consumption is calculated (blue curve): it is always positive

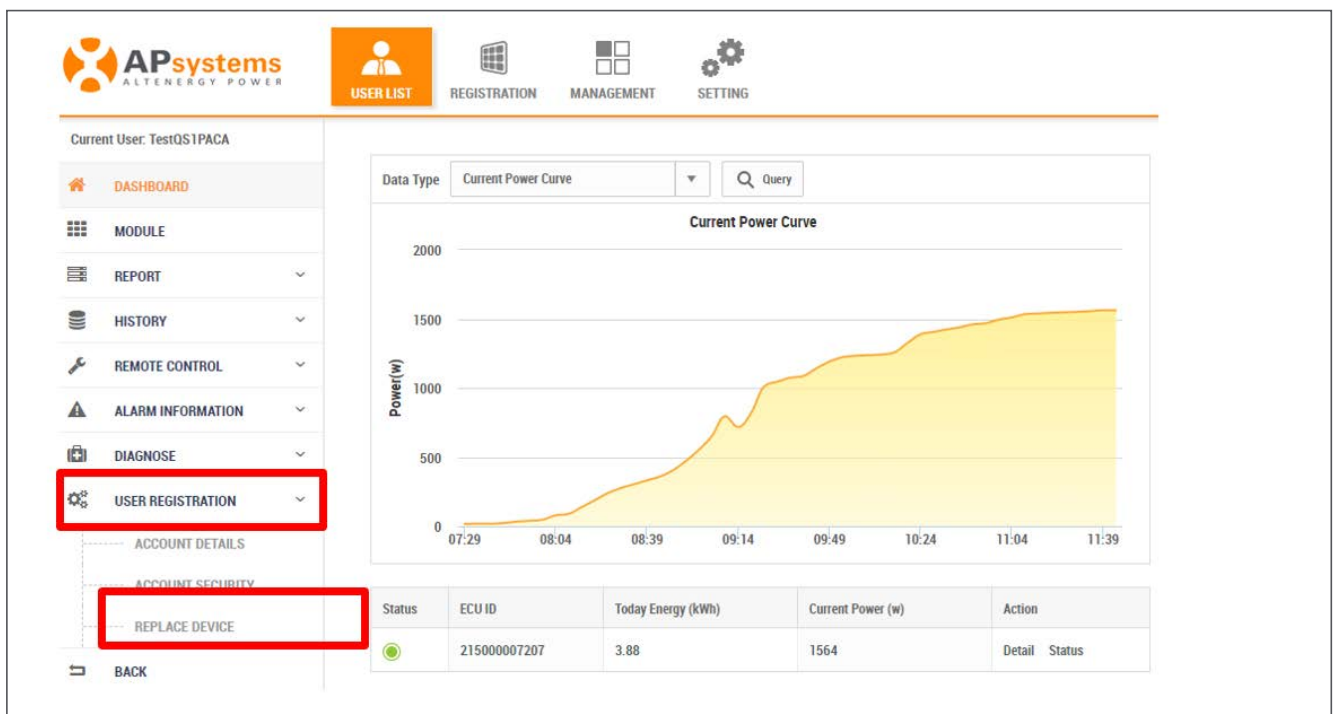
From your EMA Installer Account, enter the “User Account” where the microinverter has been replaced. Click **“User Registration”**, then **“Replace Device”**

Menu Items: DASHBOARD, MODULE, REPORT, HISTORY, REMOTE CONTROL, ALARM INFORMATION, DIAGNOSE, **USER REGISTRATION**, ACCOUNT DETAILS, ACCOUNT SECURITY, **REPLACE DEVICE**, BACK

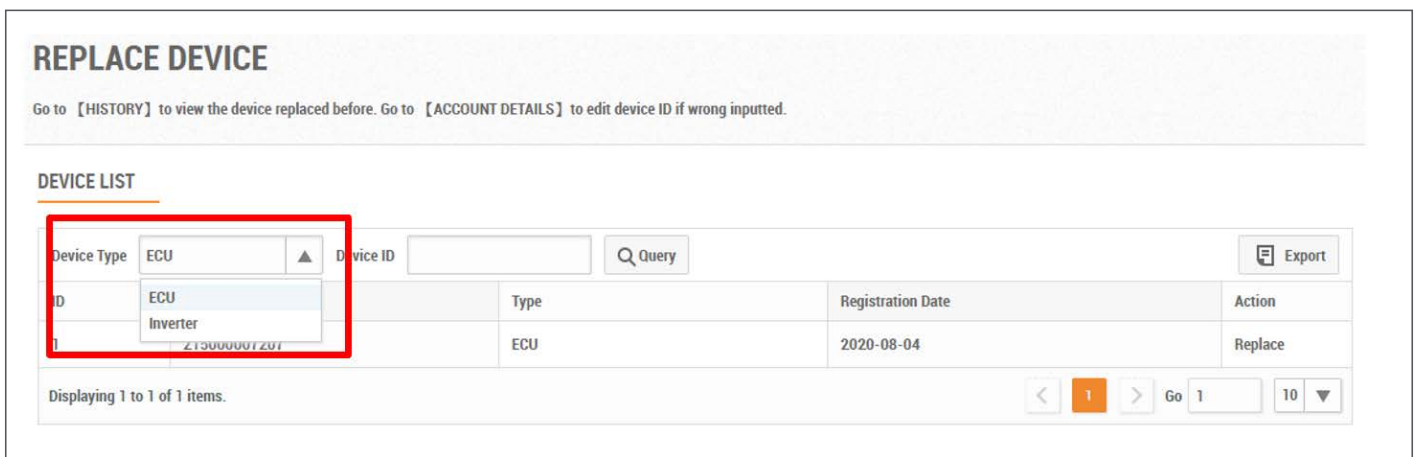
Select **“Inverter”** in the drop-down menu:

REPLACE DEVICE

Go to [HISTORY] to view the device replaced before. Go to [ACCOUNT DETAILS] to edit device ID if wrong inputted.

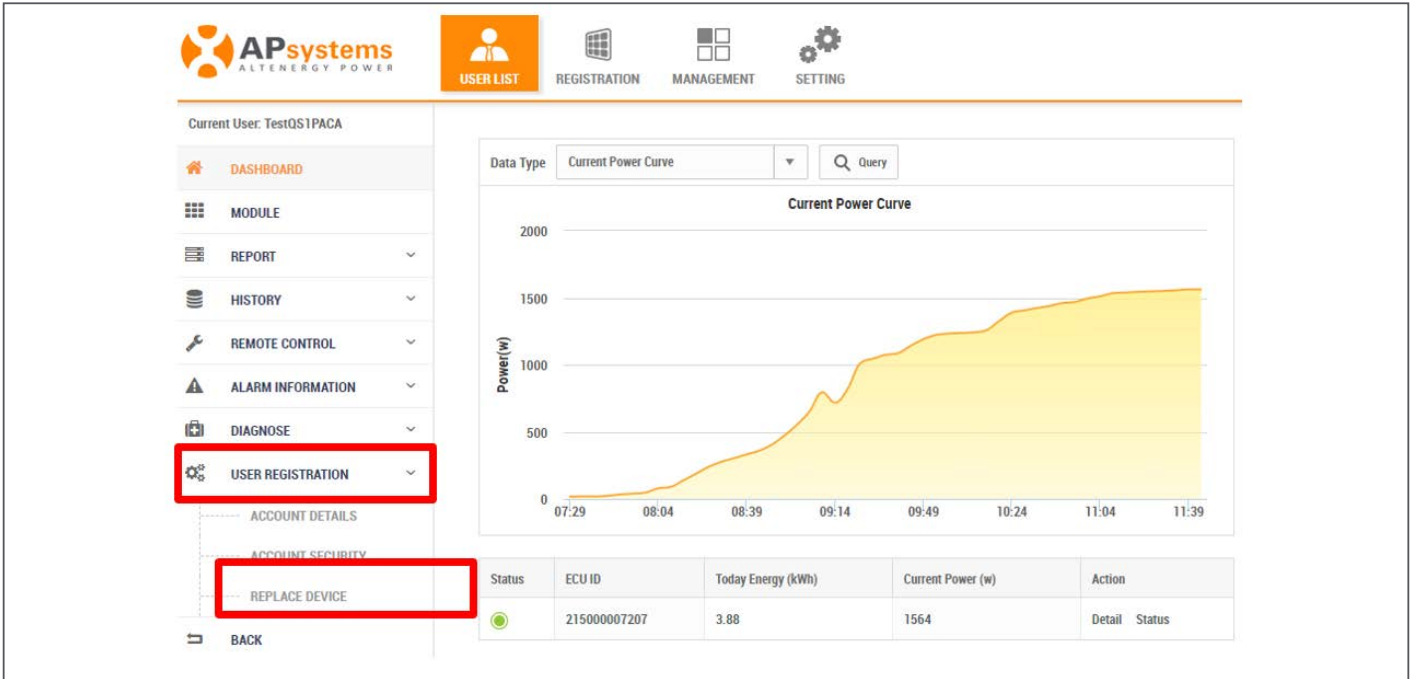
The screenshot shows the APsystems user dashboard for 'TestQ51PACA'. The left sidebar contains navigation options: DASHBOARD, MODULE, REPORT, HISTORY, REMOTE CONTROL, ALARM INFORMATION, DIAGNOSE, and **USER REGISTRATION** (highlighted with a red box). Below these are sections for ACCOUNT DETAILS and ACCOUNT SECURITY, with **REPLACE DEVICE** (also highlighted with a red box) under ACCOUNT SECURITY. The main content area displays a 'Current Power Curve' graph showing power (w) over time from 07:29 to 11:39. Below the graph is a table with the following data:

- Replace the ECU on-site. Check that everything is working properly while on-site, especially that the new ECU is properly connected to the internet router.
- When replacing an ECU by using the «**Replace Device**» function, it is not necessary to input all the inverters UID's again in the new ECU. All data from the prior ECU will be saved and transferred in the new ECU.
- From your EMA Installer Account, enter the “User Account” where the microinverter has been replaced. Click “**User Registration**”, then “**Replace Device**”

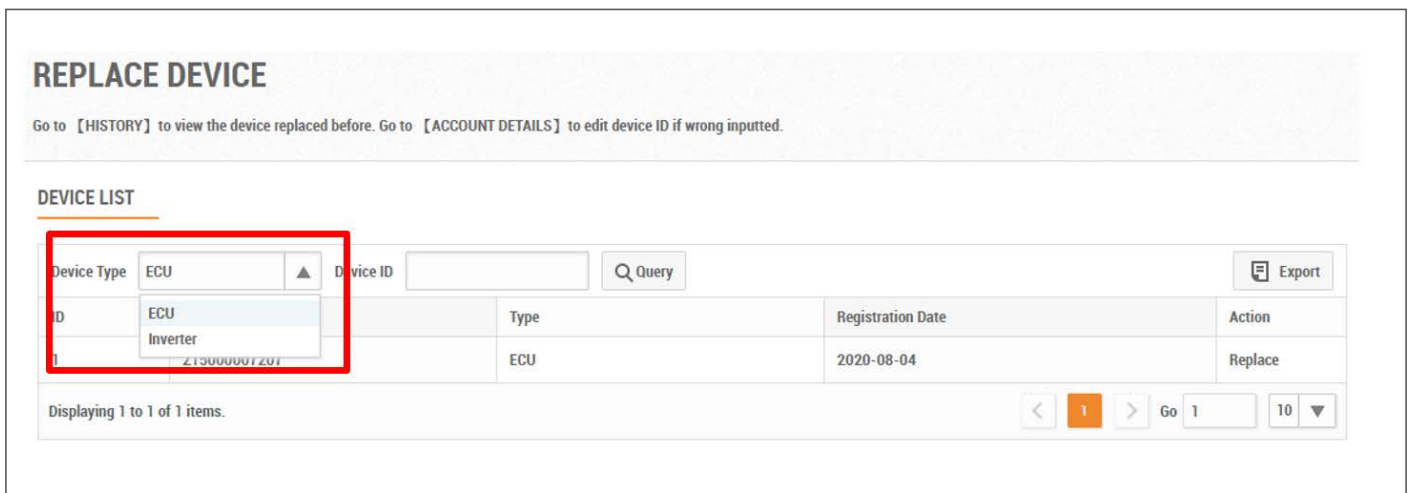
Select “ECU” in the drop-down menu:

The screenshot shows the 'REPLACE DEVICE' page. It includes instructions: 'Go to [HISTORY] to view the device replaced before. Go to [ACCOUNT DETAILS] to edit device ID if wrong inputted.' Below this is the 'DEVICE LIST' section. The 'Device Type' dropdown menu is open, showing 'ECU' and 'Inverter', with 'ECU' selected (highlighted with a red box). The table below has the following data:

ID	Type	Registration Date	Action
215000007207	ECU	2020-08-04	Replace

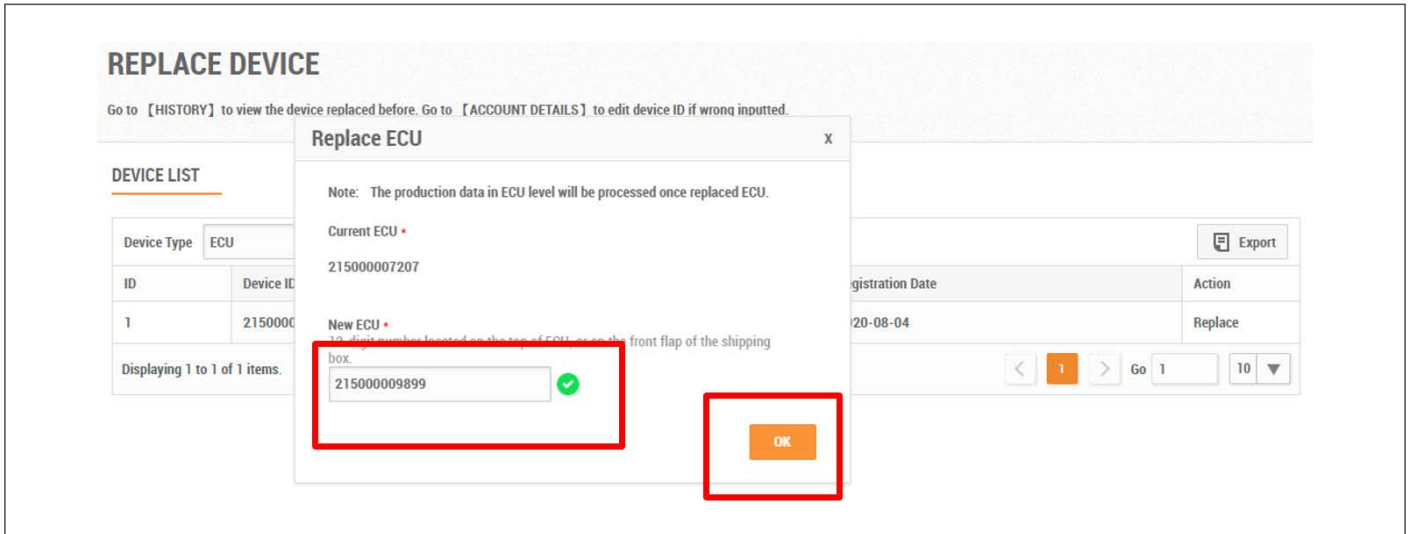
Current ECU list is displayed. Select the ECU to replace, then click **“Replace”**
Enter UID (serial number) of replacement ECU, Click “OK”

The screenshot shows the 'REPLACE DEVICE' interface. A modal dialog titled 'Replace ECU' is open, displaying the following information:

- Note: The production data in ECU level will be processed once replaced ECU.
- Current ECU: 215000007207
- New ECU: 215000009899 (highlighted with a red box and a green checkmark)
- UID: 215000009899 (highlighted with a red box)
- OK button (highlighted with a red box)
